Manhole Inspection Summary

Manhole # S51U1_004MH

Insp Date: **6/4/08 11:44 AM**

Location Address: **3100 Frankfurst Ave.**

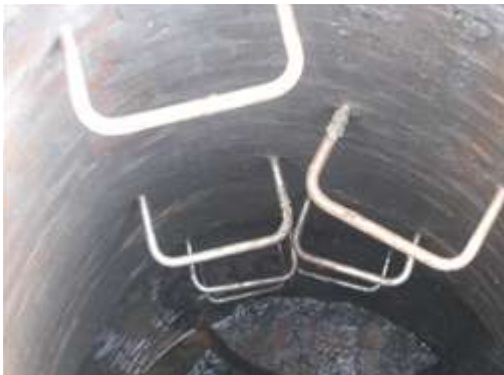
Steps

Count: **7** Missing: **0** ☐ Corroded

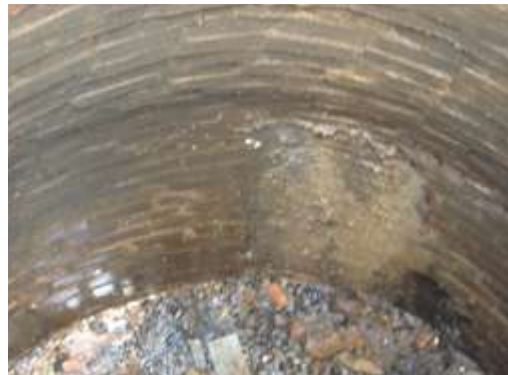
Defect 3

Condition: ☐ Sound ☒ **Cracked** ☐ Root Intrusion ☐ Loose Brick ☒ **Deteriorated**

Infiltration: ☐ None ☐ Joint ☐ Cracks ☐ Mortar ☐ Roots ☒ **Wall**

Infiltration

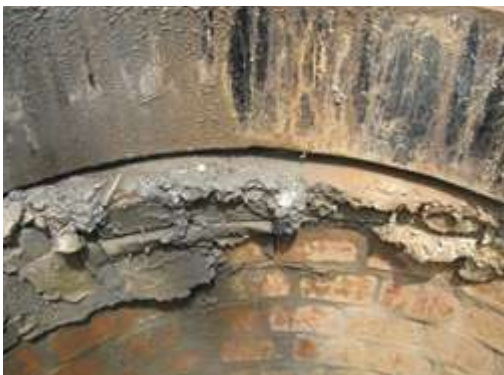
Defect 2

Condition: ☐ Sound ☒ **Cracked** ☐ Root Intrusion ☐ Loose Brick ☒ **Deteriorated**

Infiltration: ☐ None ☒ **Joint** ☐ Cracks ☐ Mortar ☐ Roots ☐ Wall

Frame-Chimney joint.

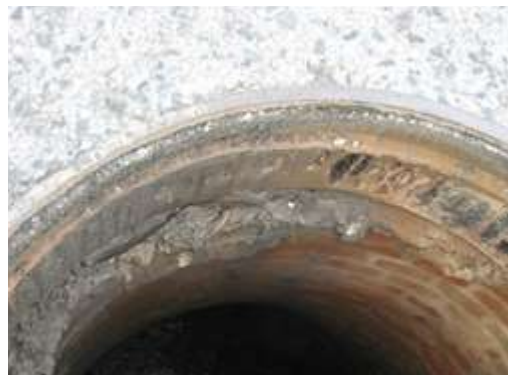
Defect 1

Offset: **2** (in.)

Frame offset

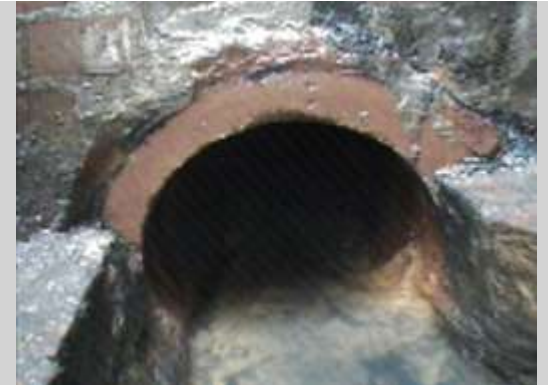
12 O'Clock Outflow

12 in. Circular Gravity Sewer
Pipe Out @ 12 O'Clock

Pipe Height: **12** (in.) Rod and Bar (Angled)
Pipe Material: **Clay** ☐ Pipe Lined
Invert Depth: **12.68** (ft.) Flow Characteristics: **Slow**
Deposits: ☒ None ☐ Mud ☐ Sludge ☐ Debris ☐ Grease
Silt Depth: (in.) Deposits Extent:
Infiltration: **None** Pipe Seal Cond: **Sound**

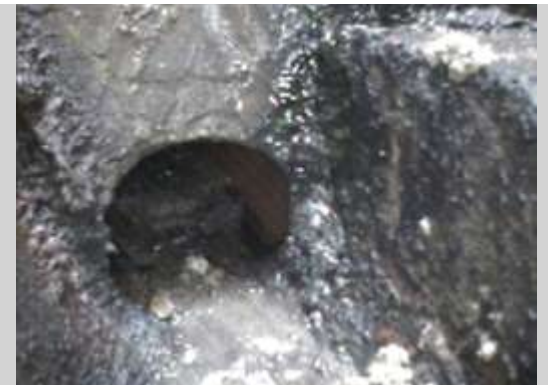
3 O'Clock Inflow

8 in. Circular Service Sewer
Pipe In @ 3 O'Clock

Pipe Height: **7.2** (in.) Rod and Bar (Angled)
Pipe Material: **Clay** ☐ Pipe Lined
Invert Depth: **12.10** (ft.) Flow Characteristics: **Slow**
Deposits: ☒ None ☐ Mud ☐ Sludge ☐ Debris ☐ Grease
Silt Depth: (in.) Deposits Extent:
Infiltration: **None** Pipe Seal Cond: **Sound**

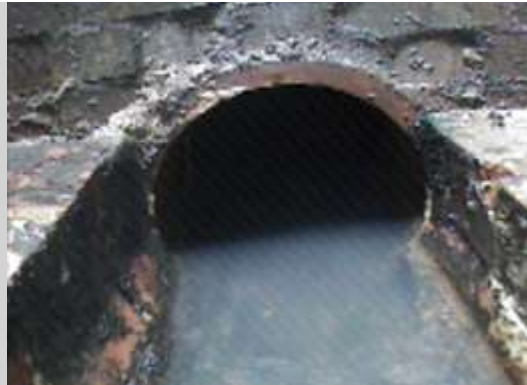
6 O'Clock Inflow

12 in. Circular Gravity Sewer

Pipe In @ 6 O'Clock

Infiltration: **None** Pipe Seal Cond: **Sound**
